**PERFORMANCE OF REHABILITATED  
ASPHALT CONCRETE PAVEMENTS  
IN THE LTPP EXPERIMENTS -  
DATA COLLECTED THROUGH  
FEBRUARY 1997**

**January 2000**

1. Report No. FHWA-RD-99-00-029		2. Government Accession No.		3. Recipient's Catalog No.	
4. Title and Subtitle PERFORMANCE OF REHABILITATED ASPHALT CONCRETE PAVEMENTS IN THE LTPP EXPERIMENTS - DATA COLLECTED THROUGH FEBRUARY 1997				5. Report Date

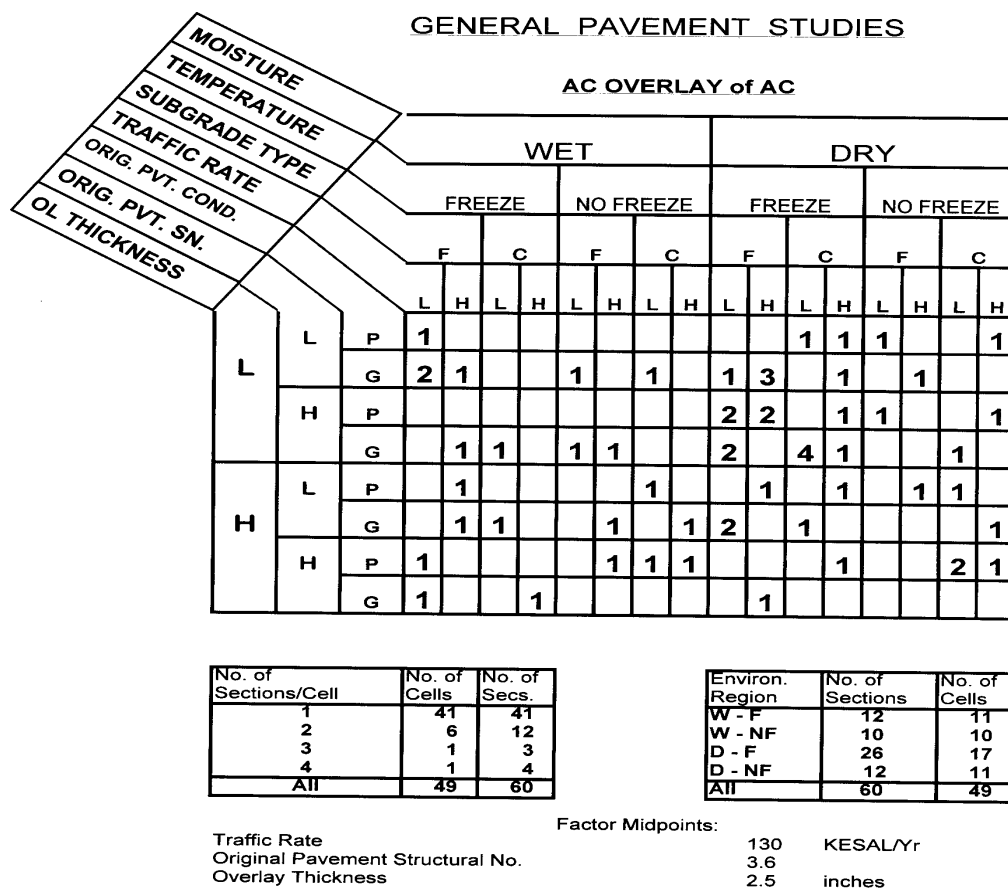
**Figure 1. Number of GPS-6A test sections in each cell of the experimental plan, AC overlay of AC pavements.**

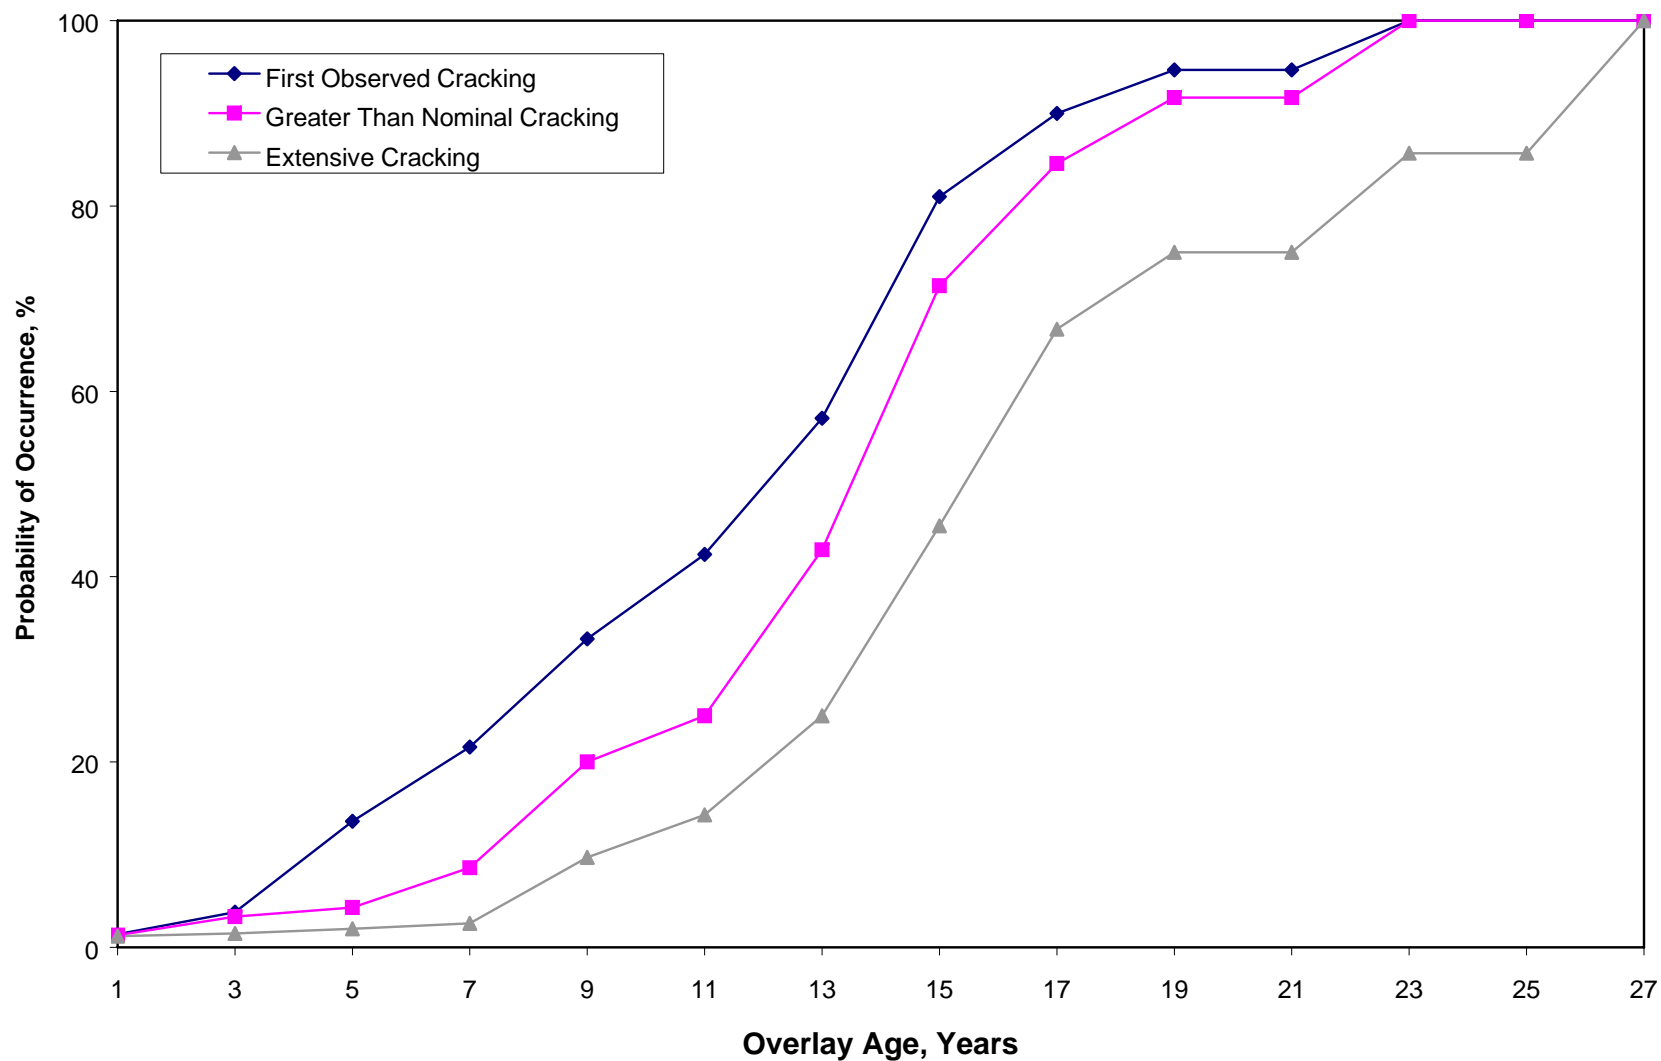
Figure 4. Probability of occurrence for different levels of fatigue cracking on the GPS-6 test sections.

The effects of original pavement condition prior to overlay placement on the fatigue cracking performance of the GPS-6A test sections can be summarized by considering the number of test sections at three levels of fatigue cracking. Table 17 summarizes the number of GPS-6A test sections with different extents of fatigue cracking for the different pavement groups and these results are comparable to table 13.

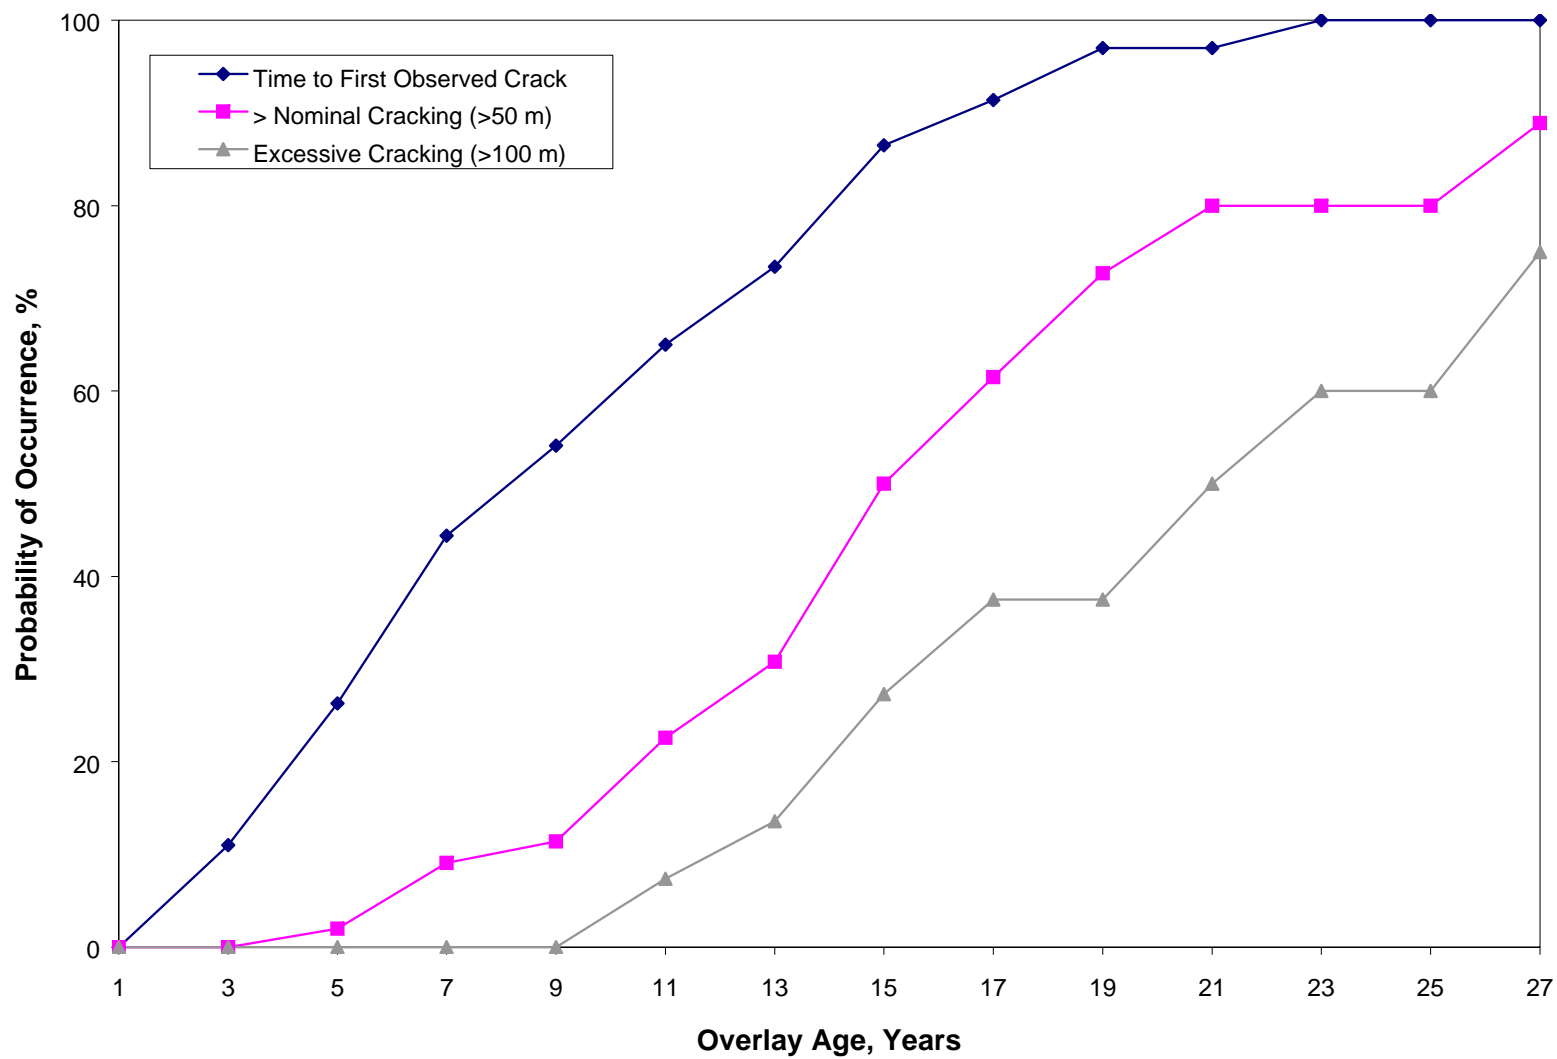
Figure 5. Probability of occurrence for different levels of LCWP on the GPS-6 test sections.

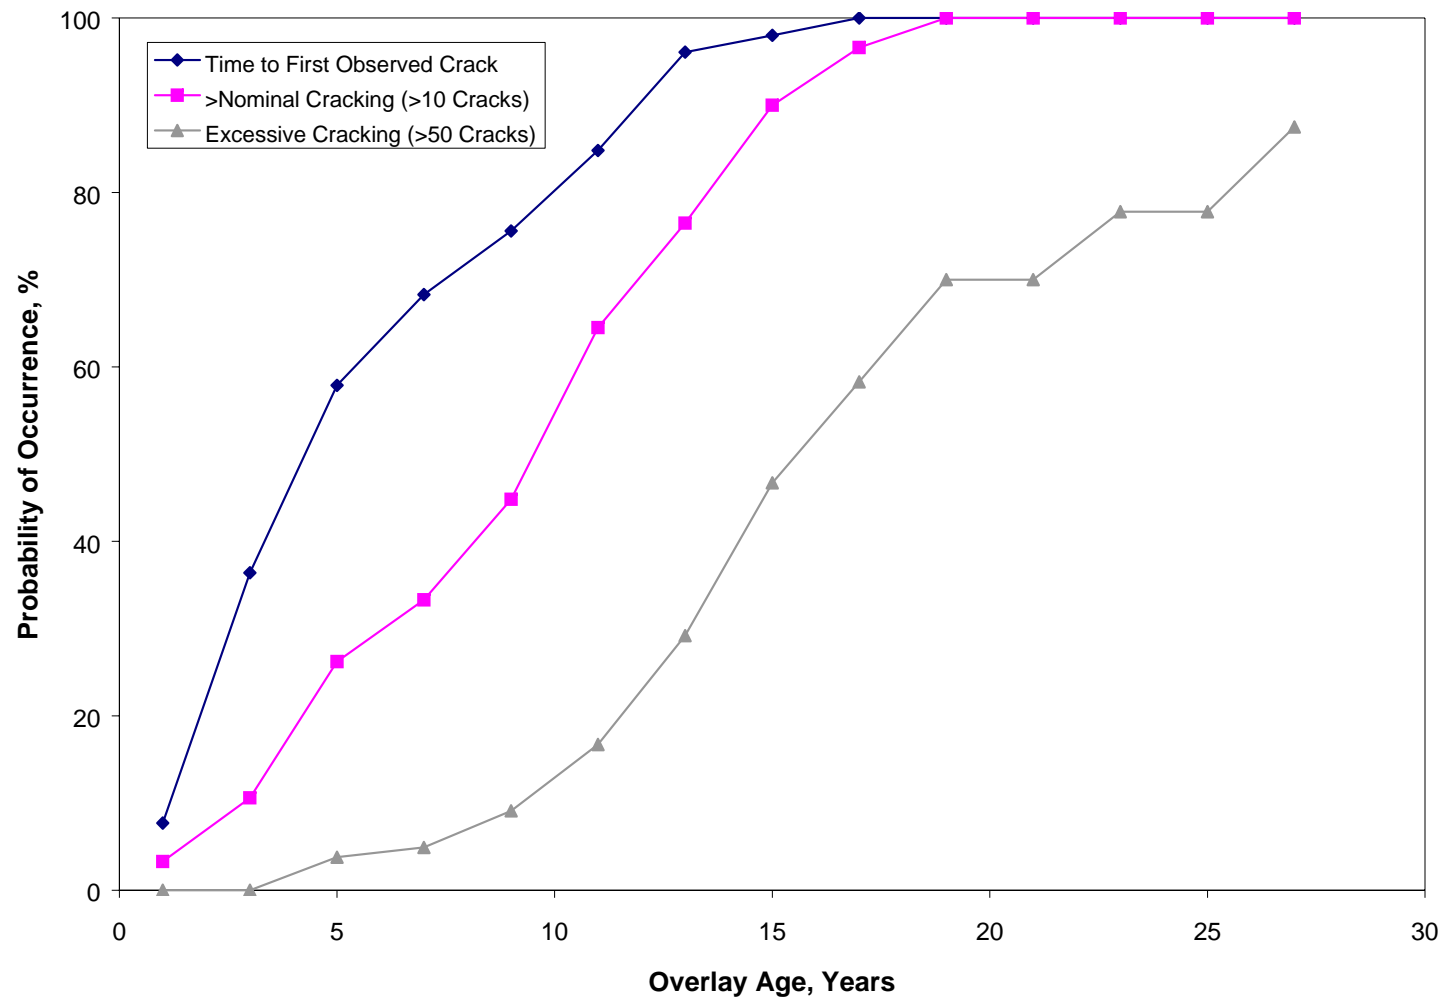
**Figure 6. Probability of occurrence of different levels of transverse cracks on the GPS-6 test sections.**

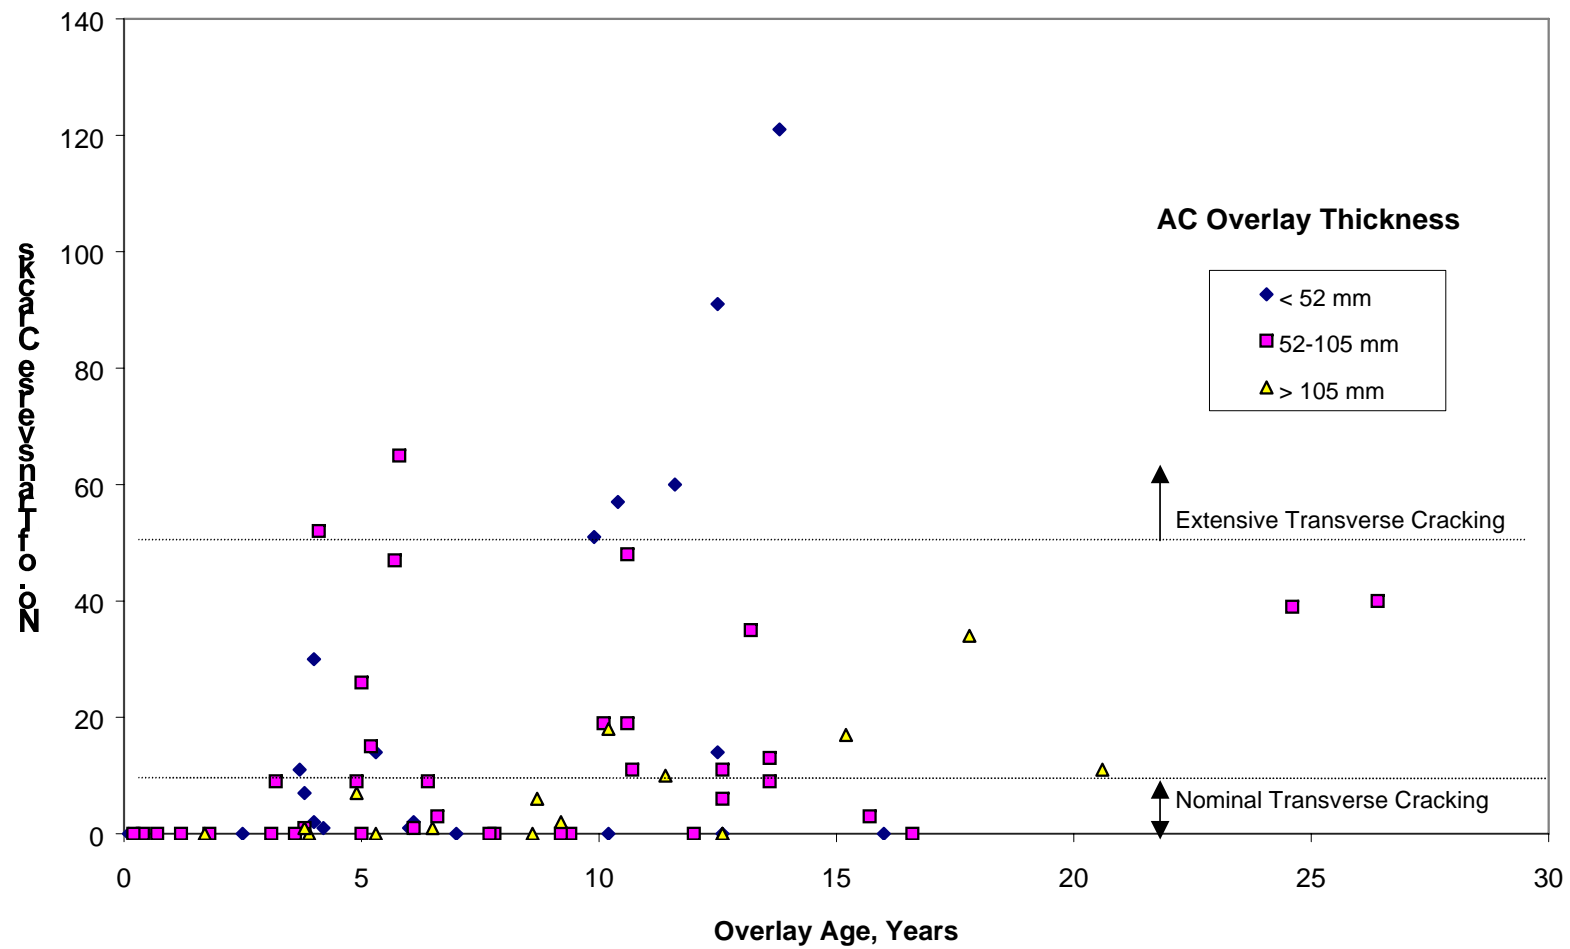
**Figure 7. Graphical relationship between overlay age and the number of transverse cracks observed on the GPS-6 test sections for different ranges of overlay thicknesses.**

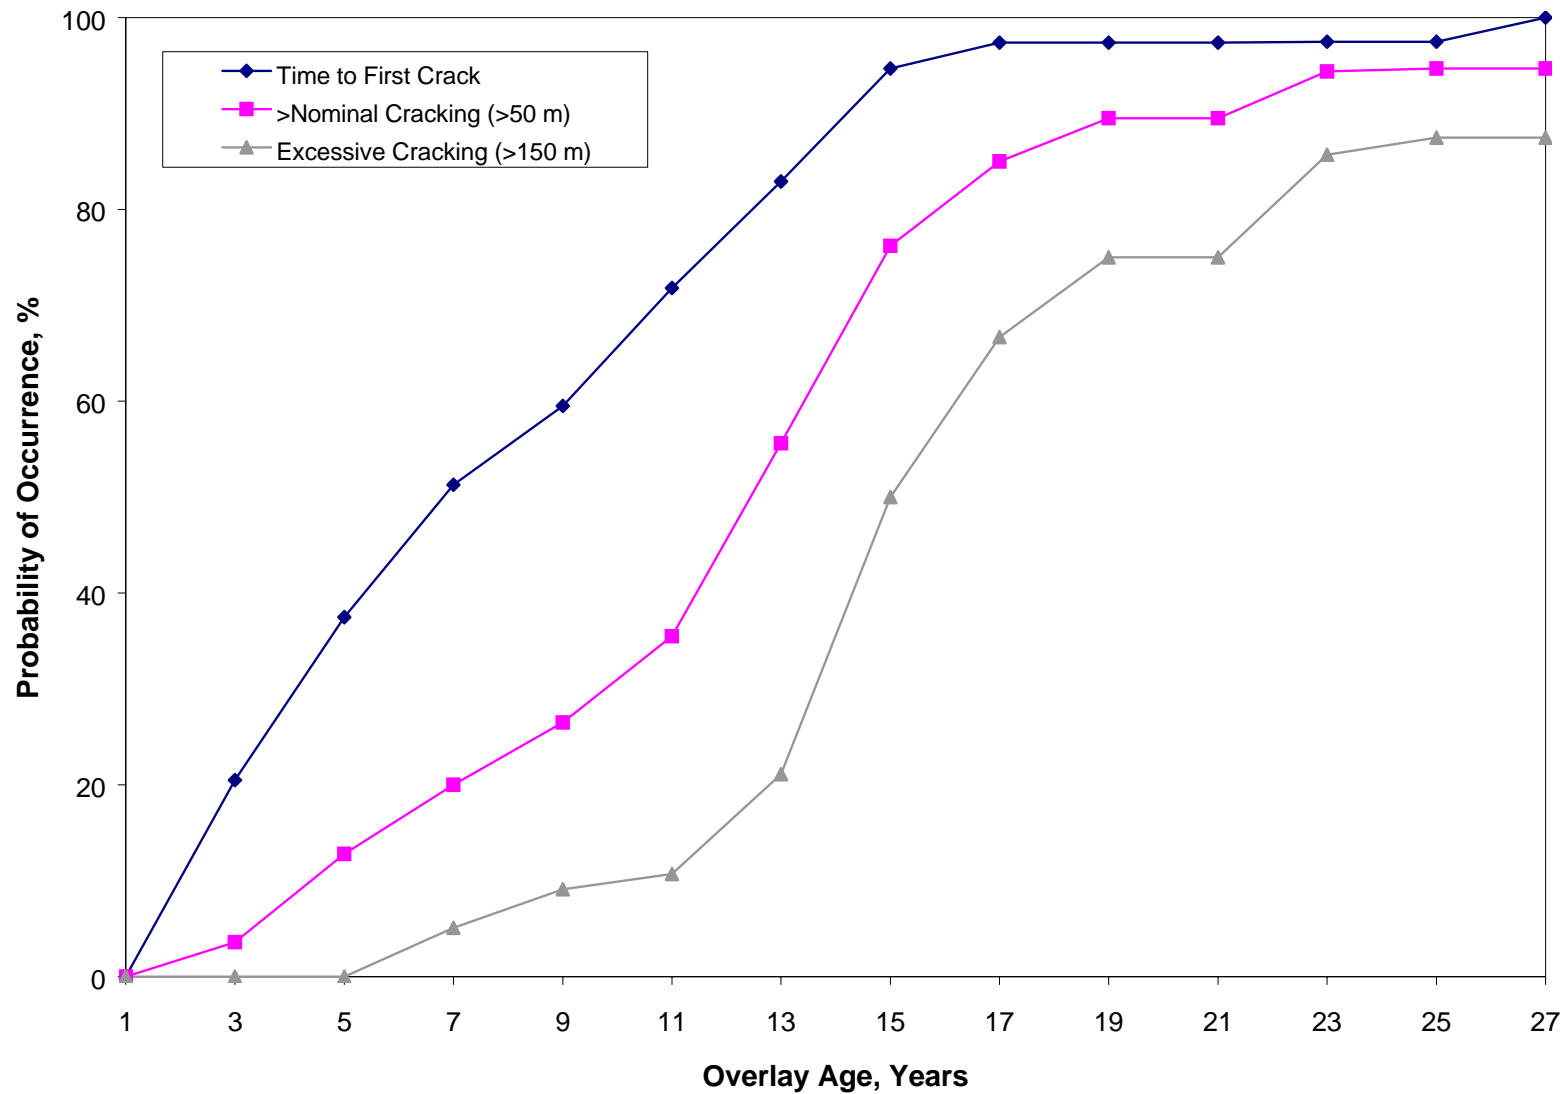
Figure 8. Probability of occurrence of different levels of LCNWP on the GPS-6 test sections.

Of the 83 test sections, 43 (52 percent) had exhibited no LCNWP, 22 (27 percent) more had exhibited 50 m or less of LCNWP, and 18 (21 percent) had exhibited more than 50 m of LCNWP.

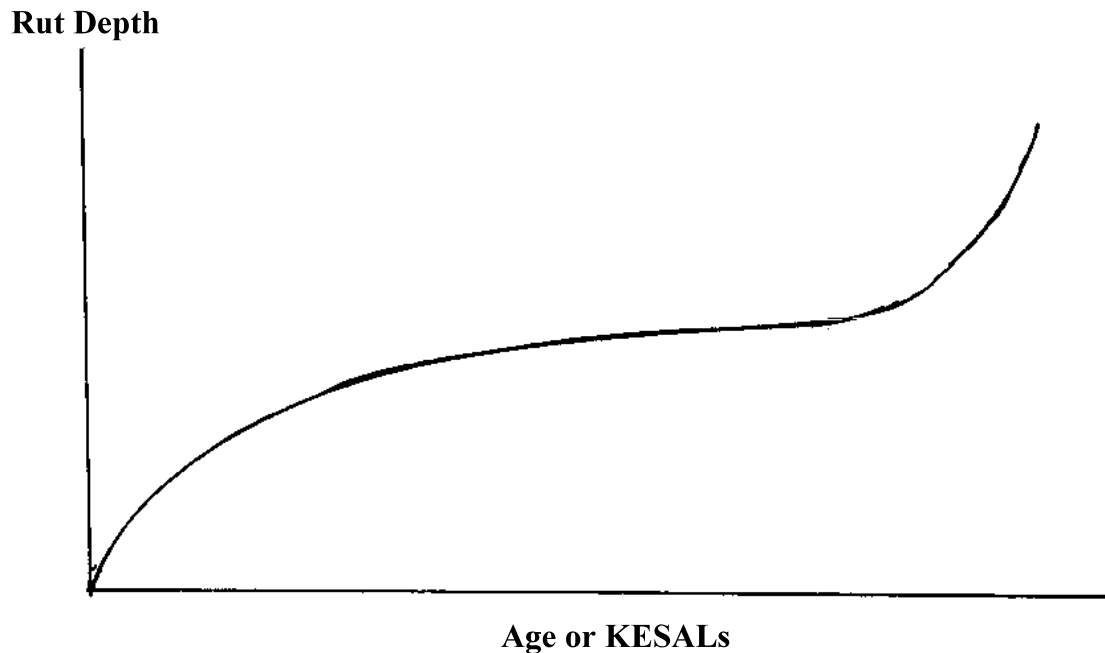
**Figure 9. General form for rutting.**

In some in-service pavements, the rutting rate increases drastically, generally exacerbated by the occurrence of other distresses in the wheel paths that allow water to soak into underlying layers or a loss of shear strength in the AC mixture. Some type of rehabilitation or reconstruction is almost always applied to avoid the rapid deterioration shown in figure 9 toward the end of the pavement's service life.

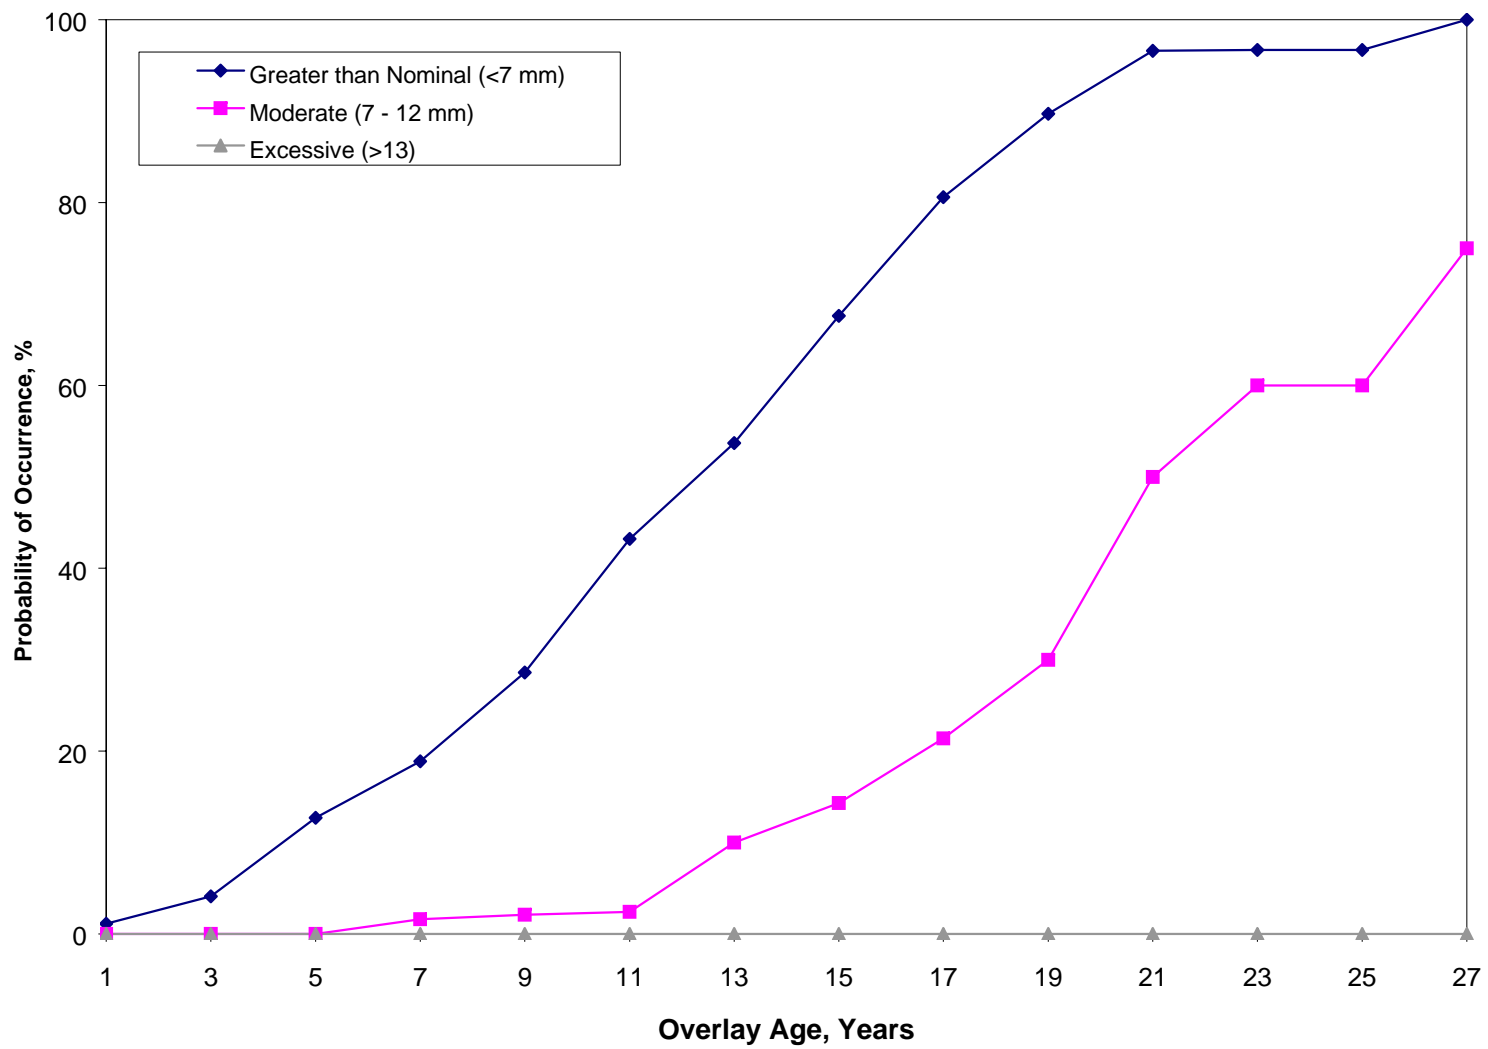
Figure 10. Probability of occurrence of different levels of rutting on the GPS-6 test sections.

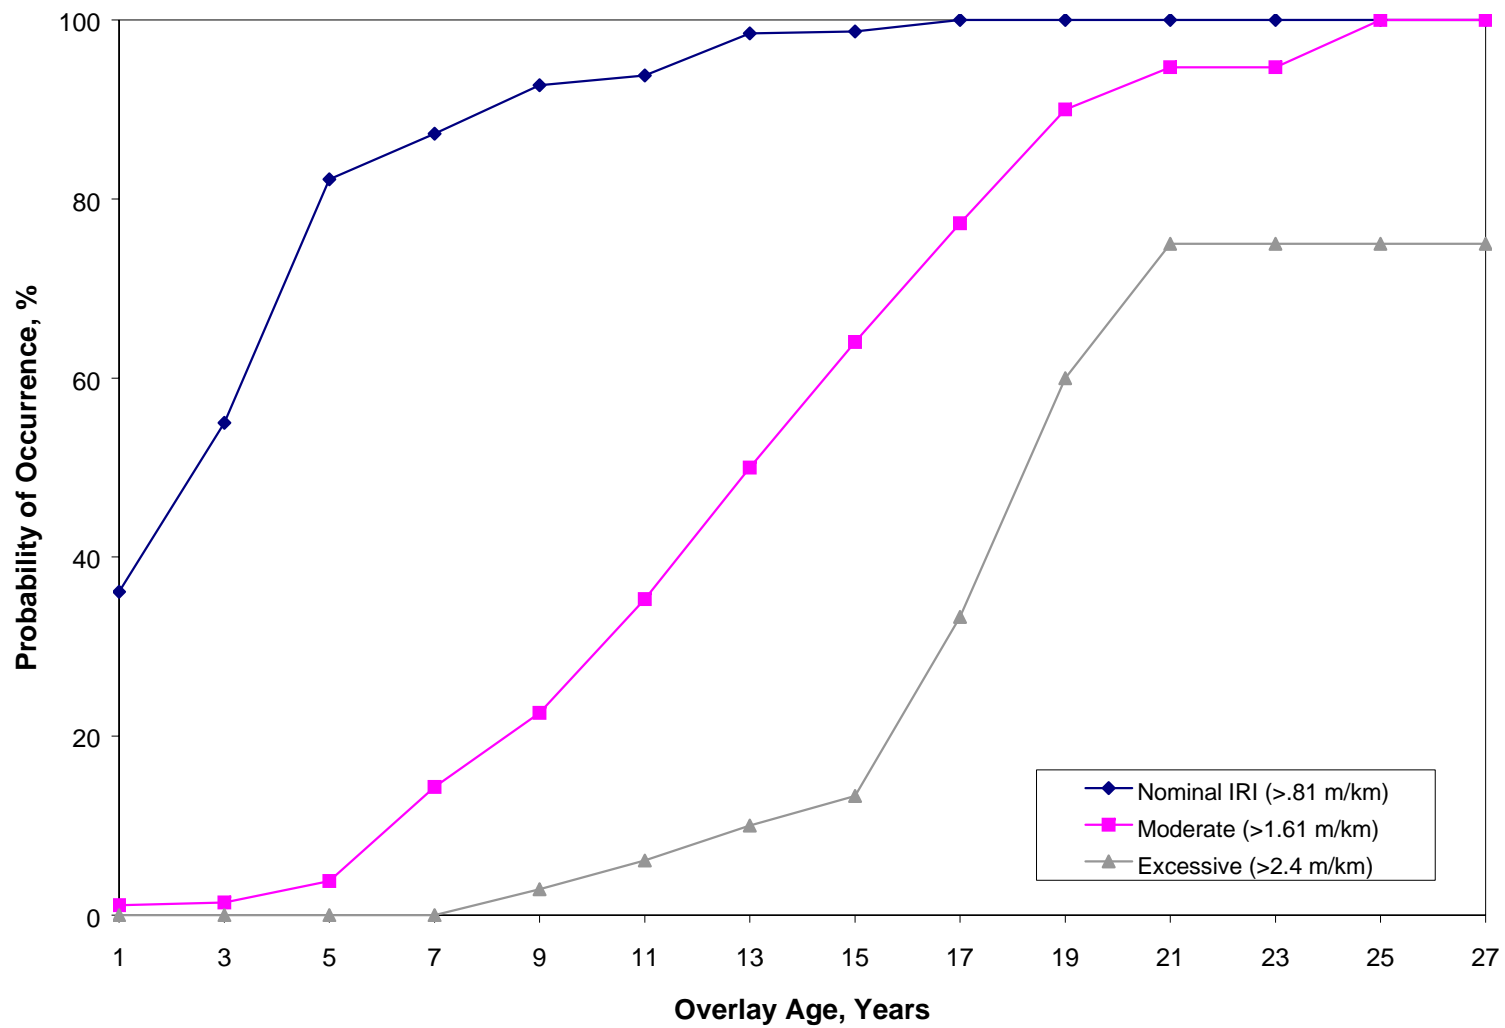
**Figure 12. Probability of occurrence of different levels of roughness on the GPS-6 test sections.**

For this limited sample, there were 9 percent more overlays that were rougher over the pavements in a good condition than those over pavements in a poor condition. It appears that the condition of the original pavement does not have an effect on the future roughness of an overlay for those test sections included in the LTPP database.

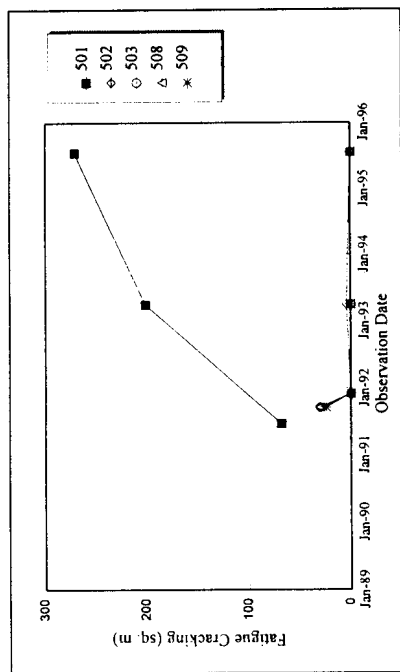
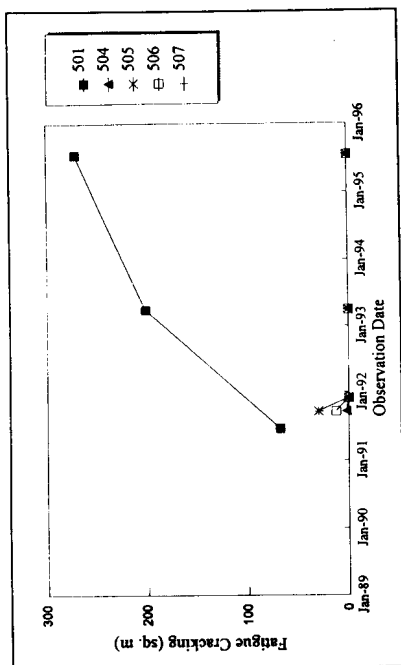
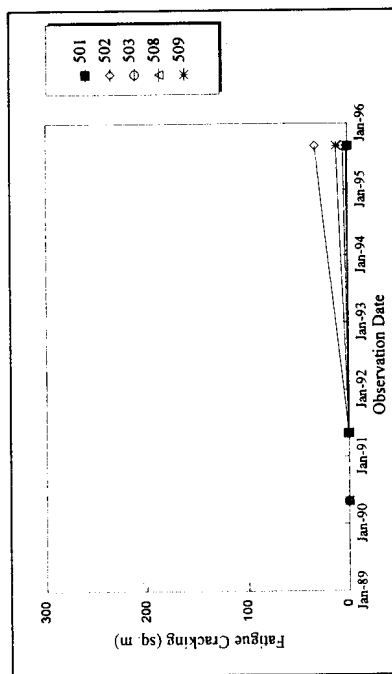
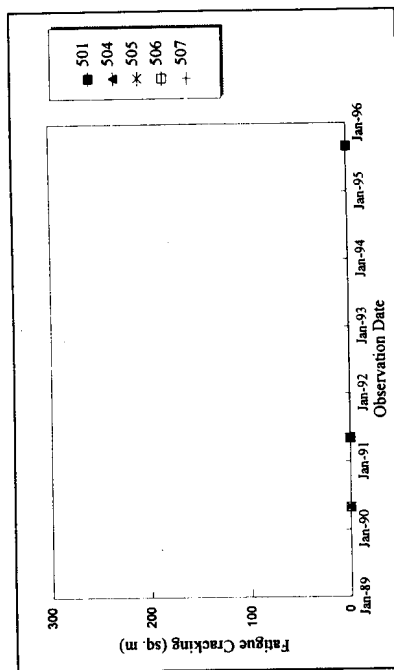
a. Fatigue cracking in recycled overlay mixtures in Alabama.

b. Fatigue cracking in virgin overlay mixtures in Alabama.

c. Fatigue cracking in recycled overlay mixtures in Alberta.

d. Fatigue cracking in virgin overlay mixtures in Alberta.

Figure 13. Fatigue cracking in Alabama and Alberta for the SPS-5 project.

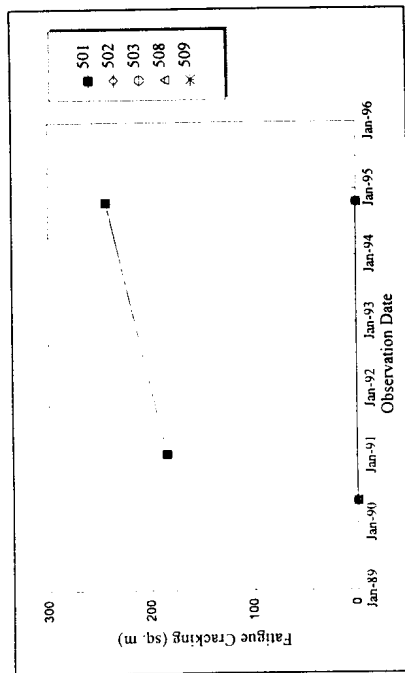
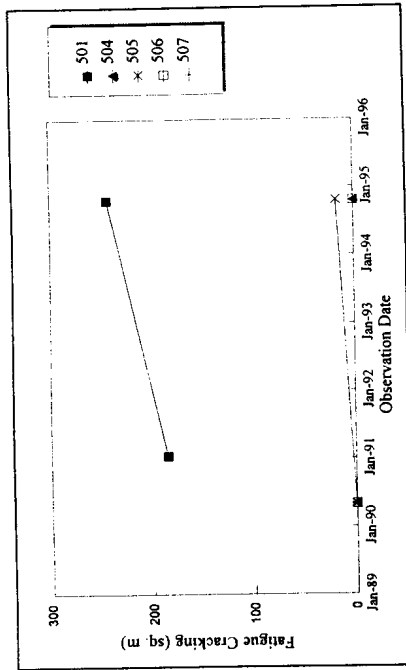
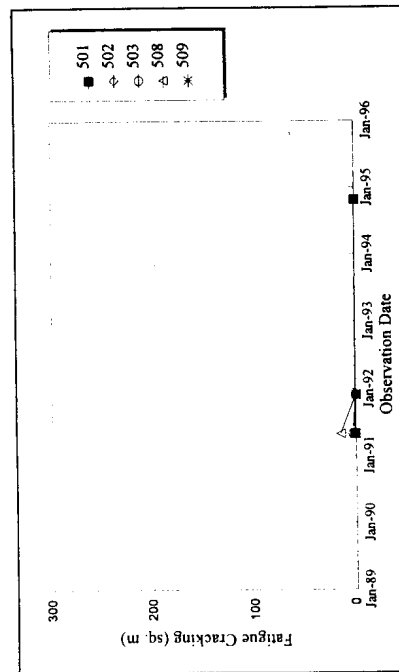
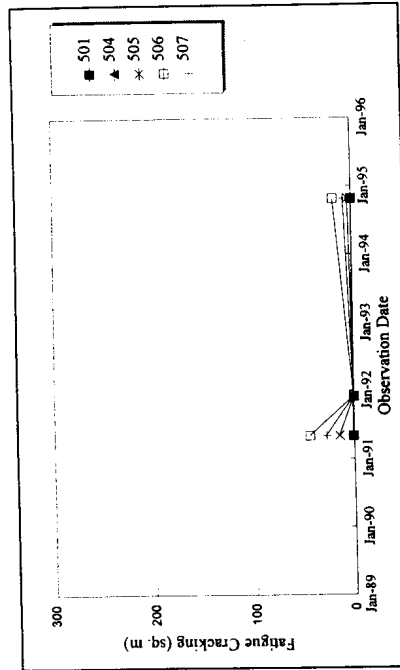
a. Fatigue cracking in recycled overlay mixtures in Arizona.

b. Fatigue cracking in virgin overlay mixtures in Arizona.

c. Fatigue cracking in recycled overlay mixtures in Colorado.

d. Fatigue cracking in virgin overlay mixtures in Colorado.

Figure 14. Fatigue cracking in Arizona and Colorado for the SPS-5 project.

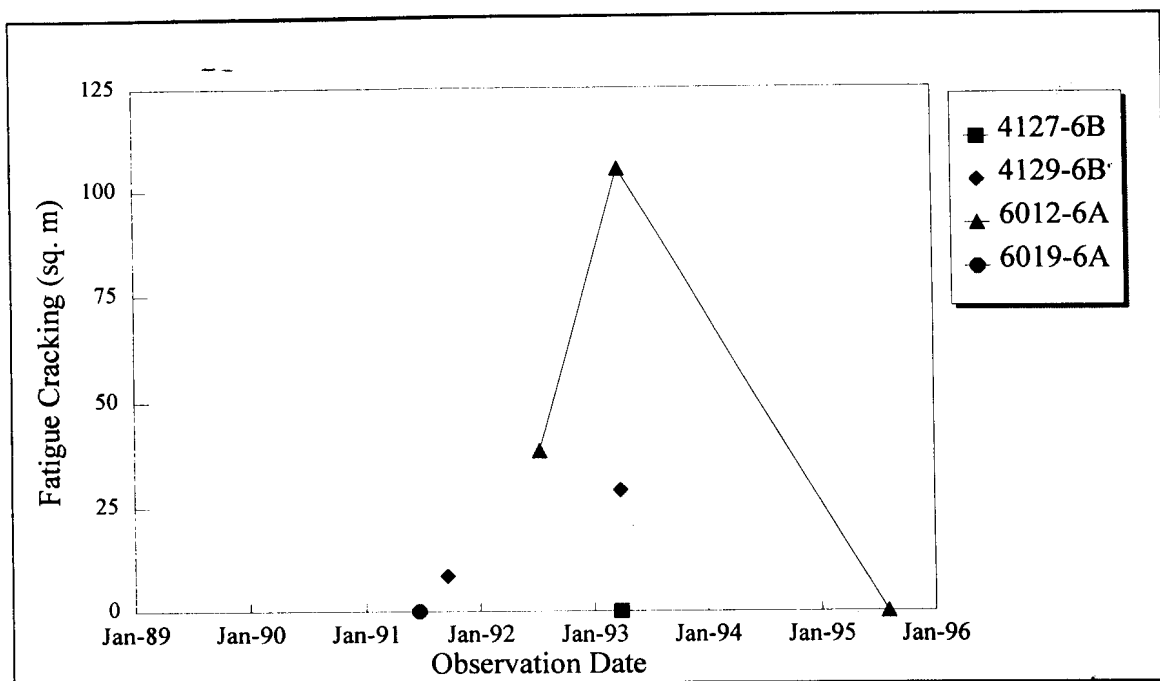
**Figure 15. Fatigue cracking in Alabama GPS-6 test sections.**

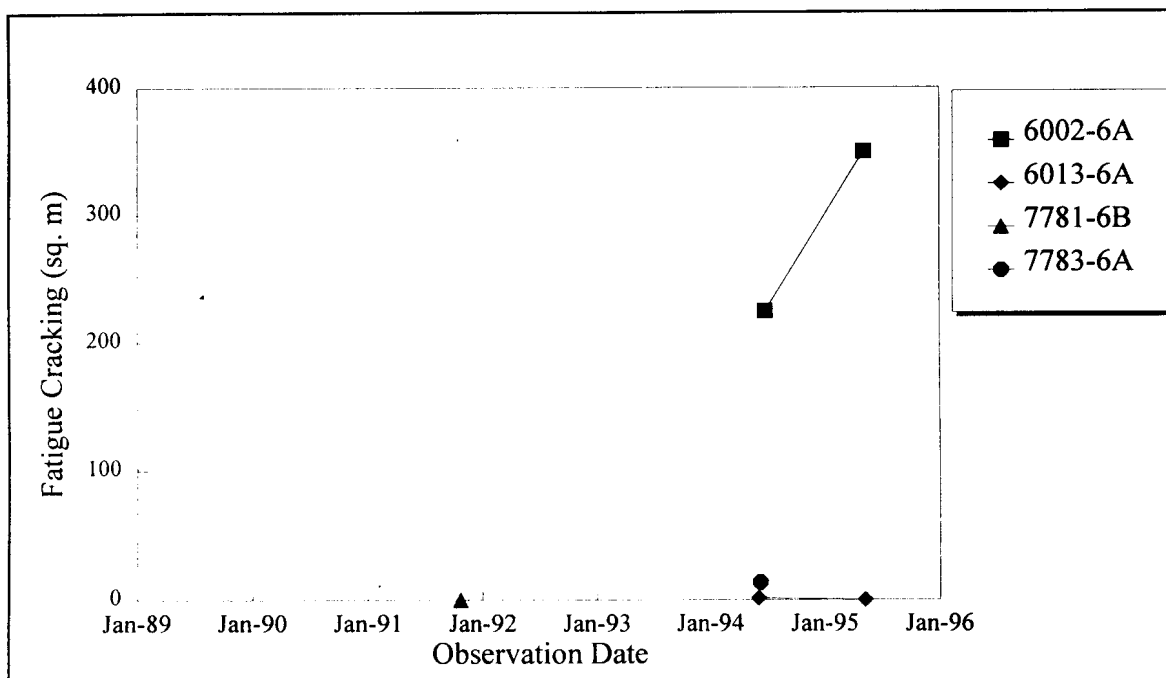
**Figure 16. Fatigue cracking in Colorado GPS-6 test sections.**

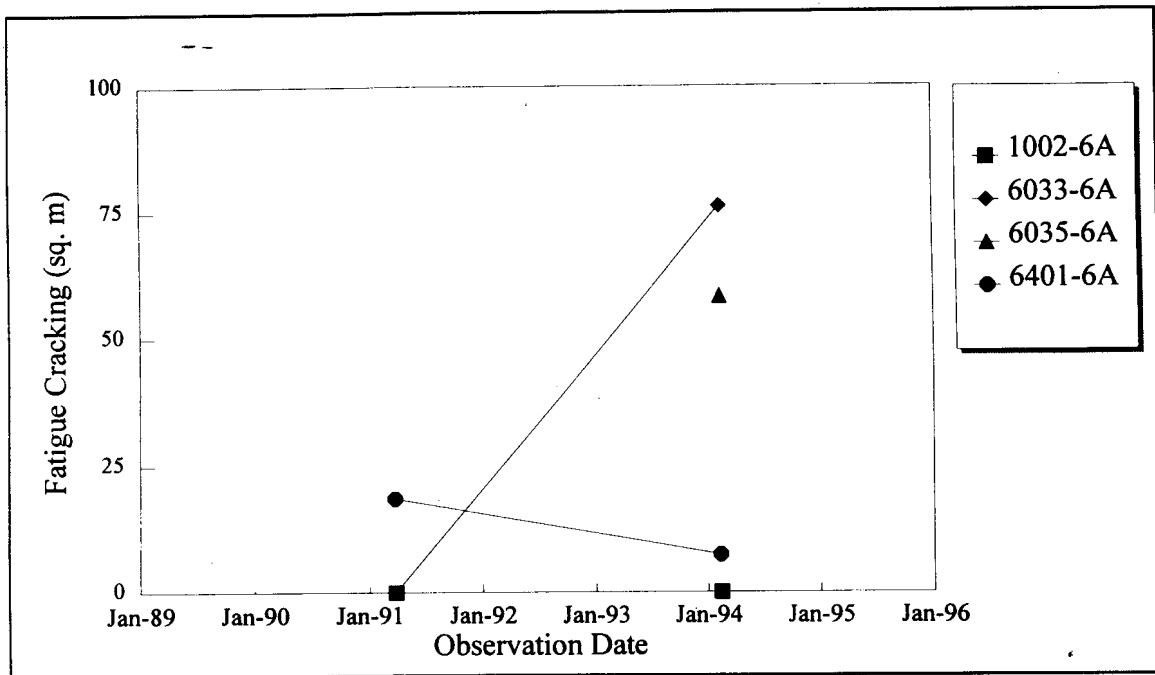
**Figure 17. Fatigue cracking in New Mexico GPS-6 test sections.**

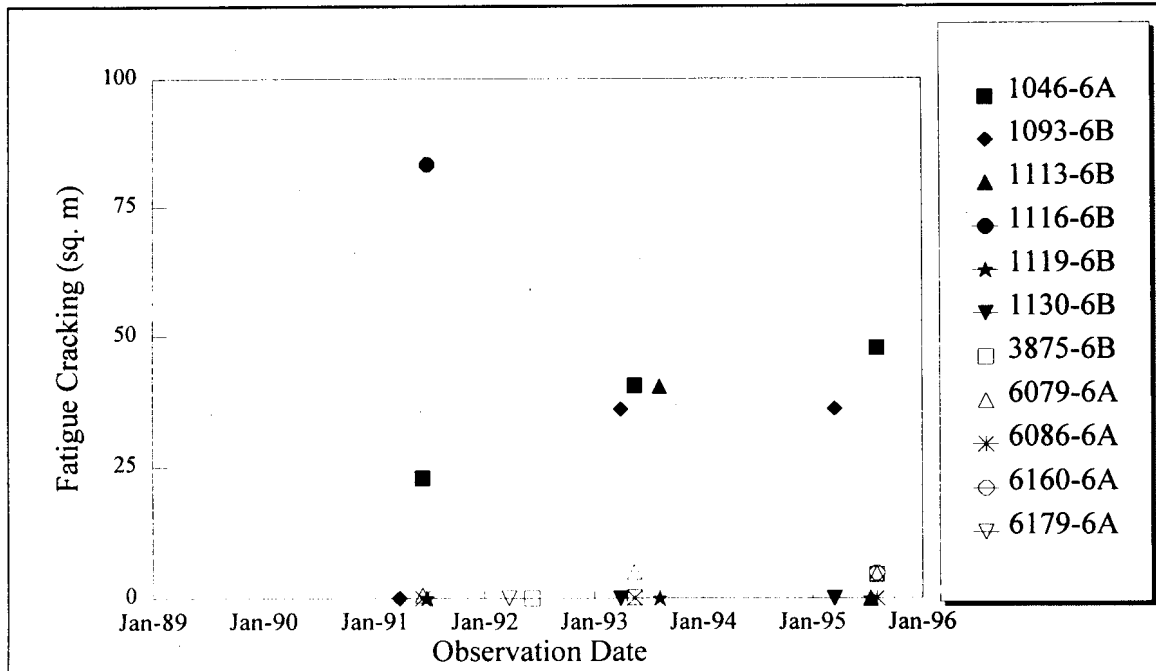
**Figure 18. Fatigue cracking in Texas GPS-6 test sections.**

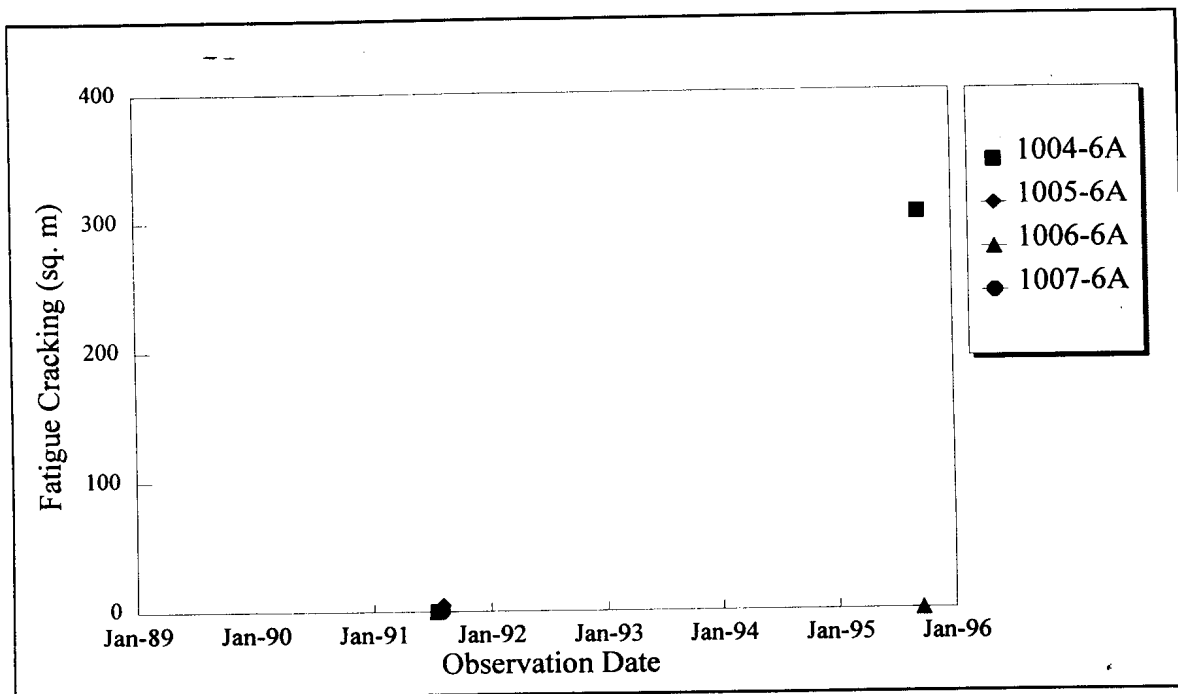
**Figure 19. Fatigue cracking in Utah GPS-6 test sections.**

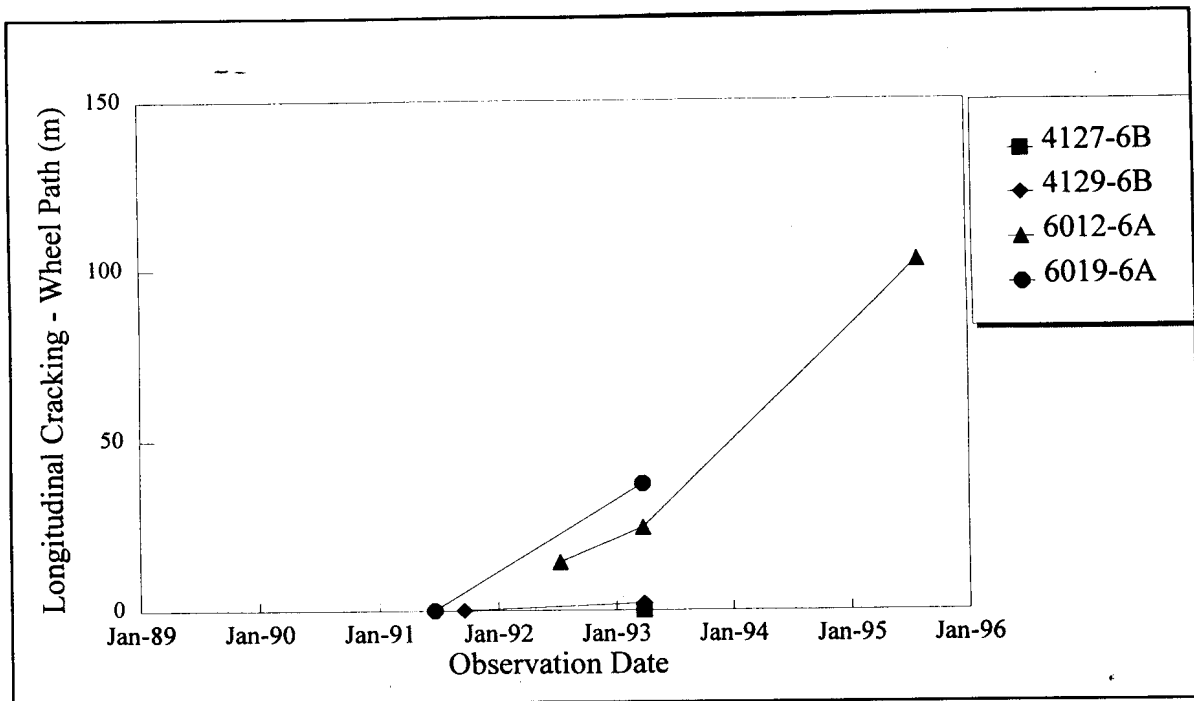
Figure 22. Longitudinal cracking in wheel paths in Alabama GPS-6 test sections.

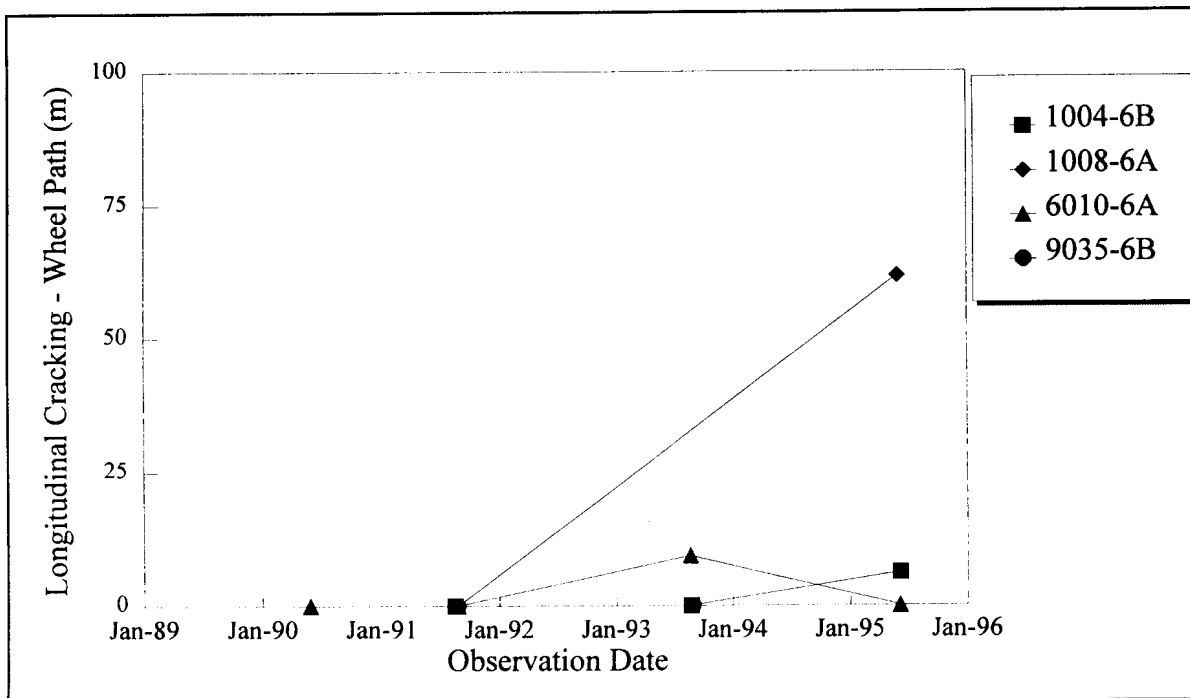
Figure 23. Longitudinal cracking in wheel paths in Alaska GPS-6 test sections.

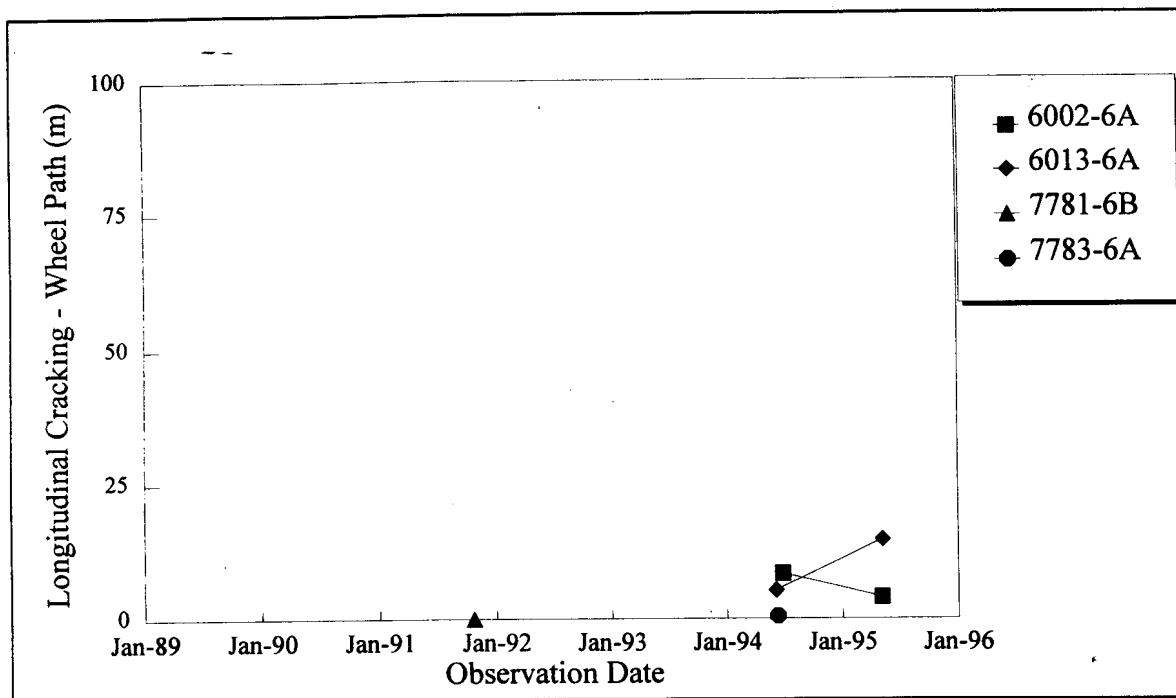
**Figure 24. Longitudinal cracking in wheel paths in Colorado GPS-6 test sections.**

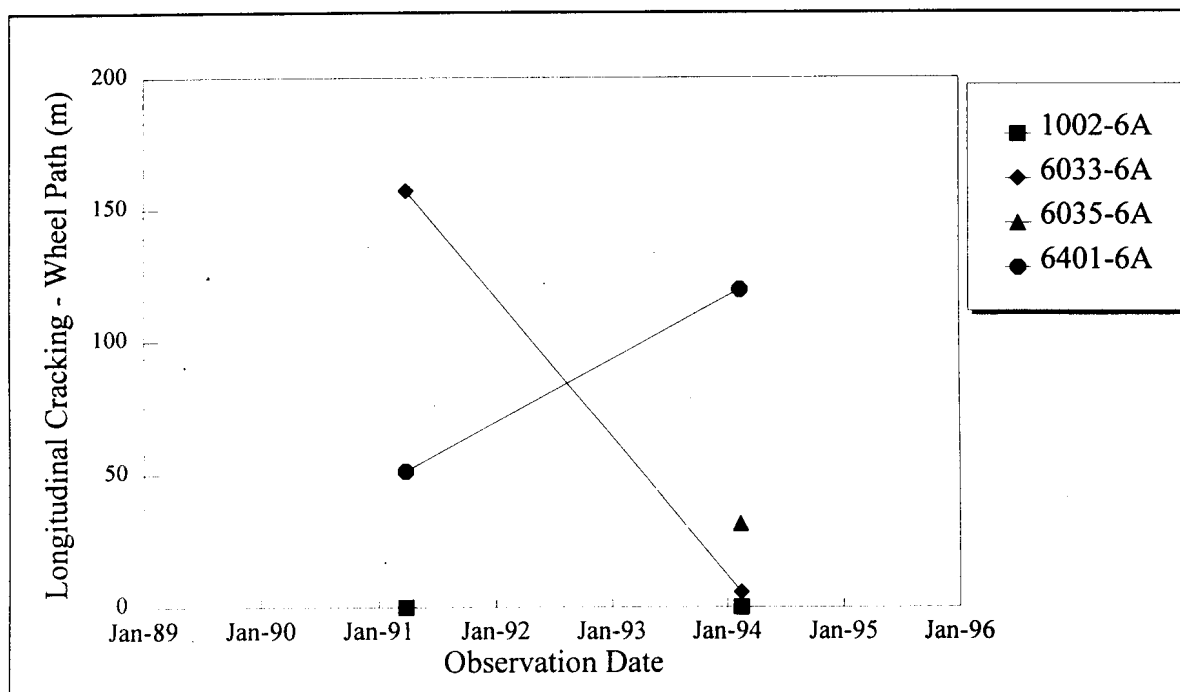
**Figure 25. Longitudinal cracking in wheel paths in New Mexico GPS-6 test sections.**
